BELZONA PROTECTS SLUG CATCHERS AGAINST EROSION AND CORROSION

ID: 418

Slug catchers destined for gas processing plant

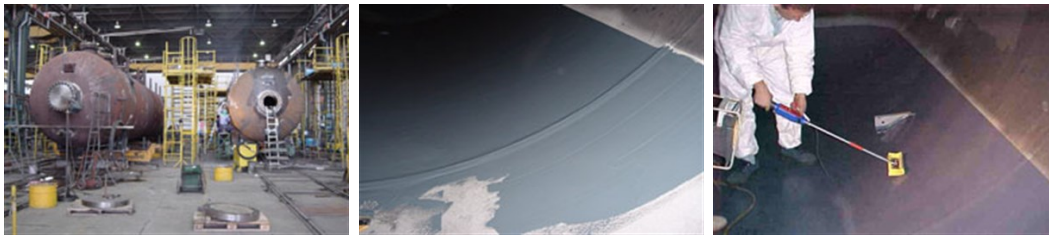
Photograph Descriptions

- * Two of the slug catchers ready for internal coating. ,
- * The Belzona® 1391 being applied. ,
- * Sponge testing the Belzona® 1391 to ensure no application defects were present in the coating. ,

Application was carried out in accordance with Belzona Know-How System Leaflet TCC-3. Particular care was taken to maintain temperature of the substrate during application.
