# CORRODED FLANGE GROOVES REFORMED WITH BELZONA

**Industry:** Power  
**Application:** VPF-Valves, Pipes and Fittings  
**Substrate:** Steel  
**Products:** \* Belzona 1111 (Super Metal) ,  
\* Belzona 1321 (Ceramic S-Metal) ,

**Customer Location:** Hydropower plant, Switzerland  
**Application Date:** February 2012

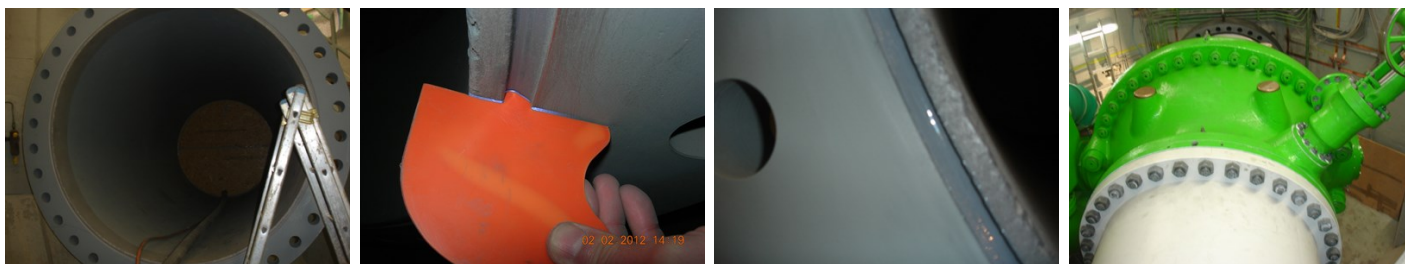
*Corrosion leading to incorrect sealing of mating surfaces*

- \* General view of the equipment before application ,
- \* A pre-cut template allows for simple, effective defining ,
- \* Belzona 1321 applied for a smoother surface ,
- \* Pressure pipe after re-assembly ,

Flange grooves in four pipe flanges. Each flange had a diameter of 1820mm; the grooves were 16mm wide and 3-4mm deep.

Application was carried out in accordance with Belzona System Leaflet VPF-1. After grit blasting the groove, Belzona 1111 was packed overthick into the groove and, using a simple pre-cut template, the original profile of the groove was recreated. Finally, a thin layer of Belzona 1321 was applied to create a smoother surface.
