# Corroded Amine Vessel Saved By Belzona

ID: 4184

**Industry:** Oil & Gas  
**Application:** TCC-Tanks and Chemical Containment Areas  
**Substrate:** Mild Steel  
**Products:** \* Belzona 1511 (Super HT Metal),  
\* Belzona 1591 (Ceramic XHT Metal),

**Customer Location:** Queensferry  
**Application Date:** October 11

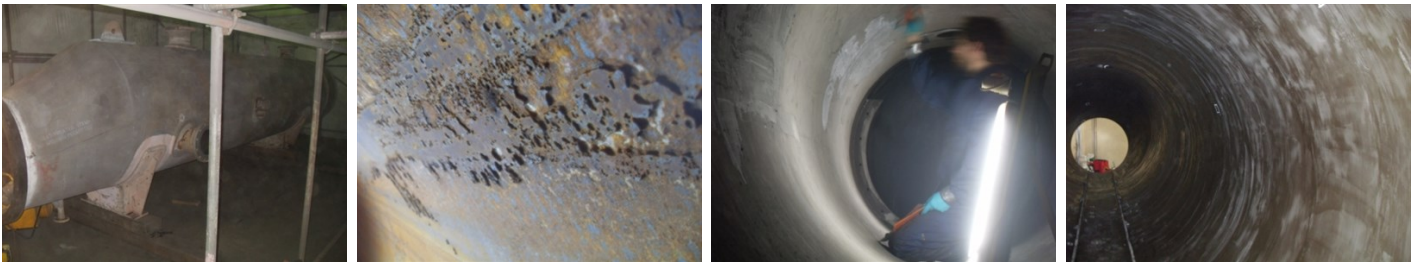
## Photograph Descriptions

\* Picture 1 - The vessel in a contained environment for blasting. Picture 2 - Pitting and Corrosion Picture 3 - Belzona 1511 applied over pitting Picture 4 - Belzona 1591 Applied ,

An Amine Boiler had suffered from the high temperatures with a high level of pitting and corrosion

The Vessel was grit blasted to SA 2.5 75 microns minimum. All brackets had their edges radius to 3mm. Belzona 1511 Super HT Metal was used to fill in the deep pitting that had occurred. A stripe coat of Belzona 1591 was placed around brackets. Two coats of 1591 was applied with a flash blast between coats. Remedial work was carried out where necessary.
