BELZONA REPAIRS A CORRODED STORAGE TANK

ID: 4185

Customer Location: Oil storage and transportation company.
Rio de Janeiro, Brazil

Application Date: November 2011

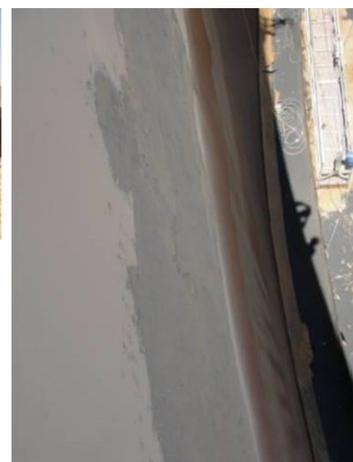
Exposure to oil and sea water at a maximum temperature of 75°C caused corrosion pitting and loss of wall thickness.

- * General view of the tank TQ-1010. ,
- * Top view of the tank. ,
- * Presence of corrosion. ,
- * Tank wall area during Belzona 1111 application. ,

Presence of corrosion in tank containing oil and sea water.

The application was carried out in accordance with Belzona Know-How System Leaflet TCC-1 as a guide. The surface was abrasive blasted and then Belzona 1111 was applied to repair the damaged areas.

Conventional welding was not a suitable option due to the unsafe conditions to the facilities and people. The Belzona technology allowed a cold repair solution, without deformation or thermal distortions and with no operational hazards. Belzona 1111 is corrosion resistant and provides excellent protection to the surface it is applied to.
