SCOOP TRAM WITH DAMAGED PIN BEARING BACK IN SERVICE WITH BELZONA AFTER ONE DAY

ID: 4188

Industry: Mining & Quarrying
Application: MPT-Mechanical Power Transmission

Customer Location: Salt mine, Germany
Application Date: November 2009

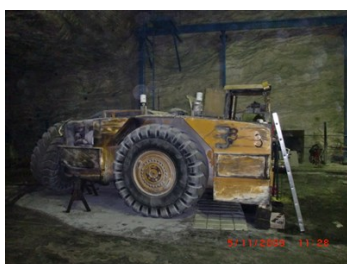
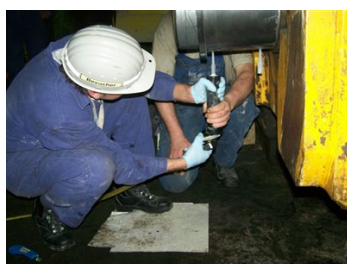
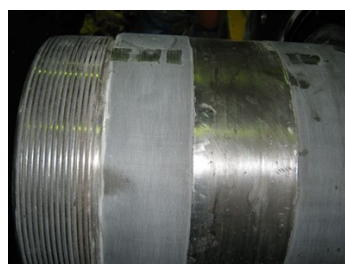
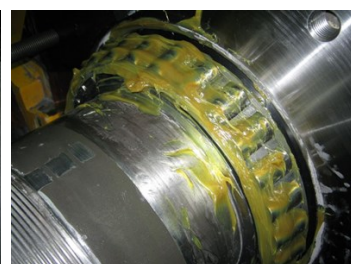
Photograph Descriptions

The severe corrosive and abrasive service conditions had led to metal loss on the articulated joint bearing pin, resulting in a relatively short life of the component.

* Scoop tram before application Injection of the Belzona material Completed application After reassembly of the bearing ,

The application was carried out in accordance with Belzona Know-How System Leaflet MPT-2.

Dismantling the pin housing for replacement would have been very time consuming and costly as the entire backing plate would have had to be detached. The Belzona forming technique not only allowed for the repairs to be completed in-situ after just one day but also significantly extended the life expectancy of the scoop tram bearing pin.
