# CLASSIC PIN-HOUSING REPAIR WITH BELZONA

ID: 419

Industry: *Mining & Quarrying*  
Application: *MPT-Mechanical Power Transmission*

Bush housing on excavator shovel

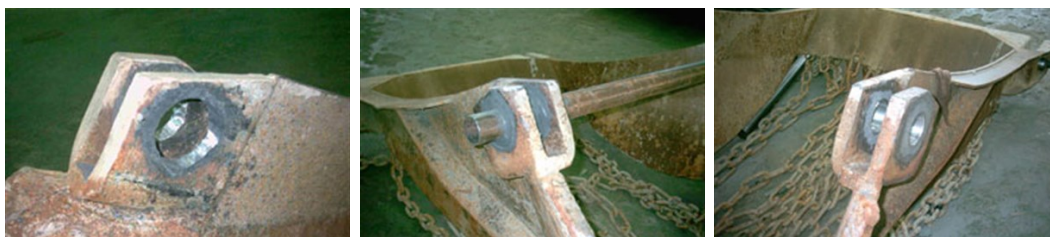
*Fretting and wear caused ovality of the bush housing due to the high forces transmitted through the pins.*

\* The damaged housing Belzona® 1111 applied and the new bushes located in the correct place by a pin between the housings The completed repair ,

Application was carried out in accordance with Belzona Know-How System Leaflet MPT-8. The surface was prepared by grinding and new steel bushes bonded into place. In order to ensure the bushes were in the correct position, a dummy pin was used to locate the bushes.
