Belzona Rebuilds Damaged Sliding Face of Milling Machine

ID: 4190

Customer Location: *Nag Hammadi, Egypt*
Application Date: *May 2006*

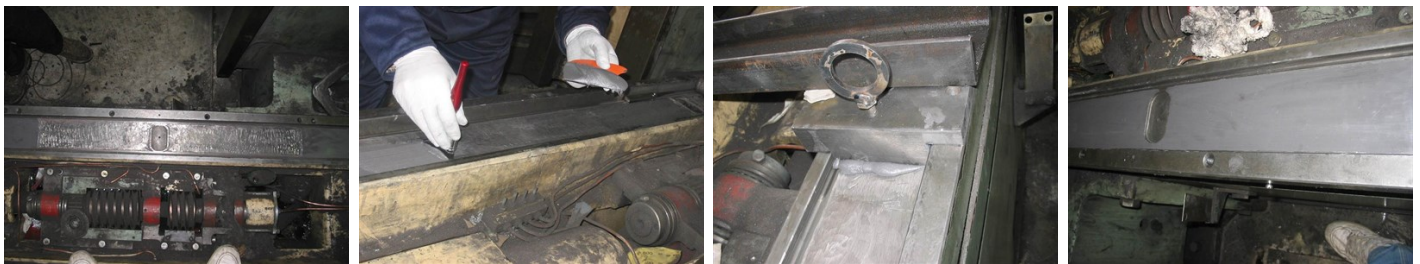
Photograph Descriptions

The horizontal mating face of the mill was damaged due to impact. Therefore this had to be rebuilt in order for the equipment to operate correctly.

- * 1. After surface preparation ,
- * 2. Product being applied ,
- * 3. Former being used. ,
- * 4. Finished repair ,

The surface was roughened by using an angle grinder. Belzona 1111 was applied in excess before a specially fabricated was used to restore it to the original dimensions.
