# Belzona Rebuilds Damaged Sliding Face of Milling Machine

Industry: Mining & Quarrying  
Application: ENC-Engines and Casings  
Substrate: Aluminium  
Products: \* Belzona 1111 (Supermetal) ,

Customer Location: Nag Hammadi, Egypt  
Application Date: May 2006

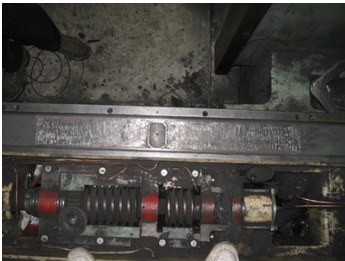
The horizontal mating face of the mill was damaged due to impact. Therefore this had to be rebuilt in order for the equipment to operate correctly.

- \* 1. After surface preparation ,
- \* 2. Product being applied ,
- \* 3. Former being used. ,
- \* 4. Finished repair ,

The surface was roughened by using an angle grinder. Belzona 1111 was applied in excess before a specially fabricated was used to restore it to the original dimensions.
