# Belzona Rebuilds Damaged Sliding Face of Milling Machine

ID: 4190

Customer Location: *Nag Hammadi, Egypt*  
Application Date: *May 2006*

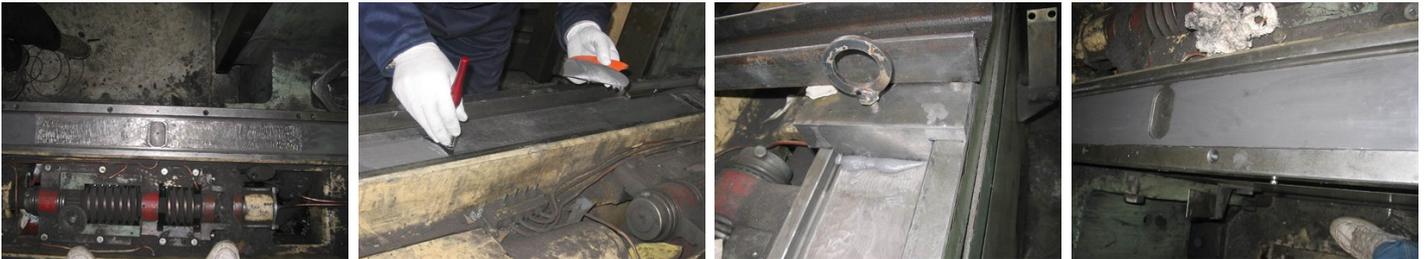
## Photograph Descriptions

*The horizontal mating face of the mill was damaged due to impact. Therefore this had to be rebuilt in order for the equipment to operate correctly.*

- \* 1. After surface preparation ,
- \* 2. Product being applied ,
- \* 3. Former being used. ,
- \* 4. Finished repair ,

The surface was roughened by using an angle grinder. Belzona 1111 was applied in excess before a specially fabricated was used to restore it to the original dimensions.
