BELZONA RESTORES CORRODED HEAT EXCHANGER

ID: 4196

Tube Sheet from chiller unit

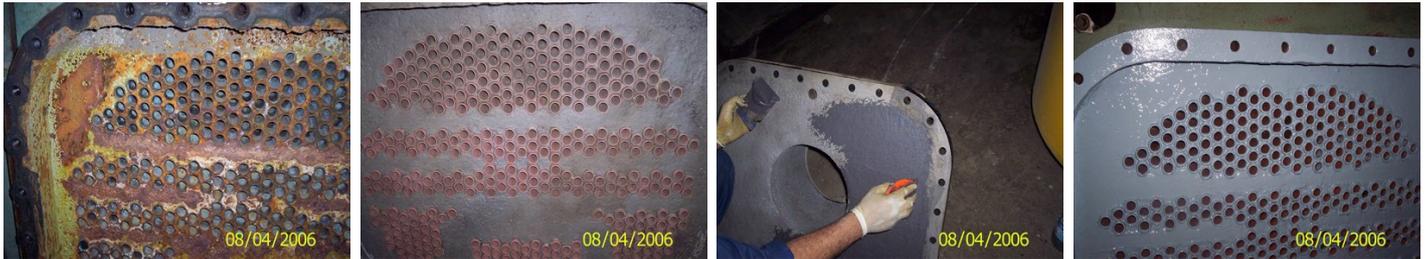
The tube sheet was badly corroded. Particularly deep erosion on tube sheet around the tubes.

- * The original corrosion damage ,
- * After Surface Preparation ,
- * Belzona 1311 application ,
- * Completed Belzona 1341 application ,

This application was carried out in accordance with Belzona Know-How System Leaflets HEX-1 and HEX-3. Belzona 1311 was used to rebuild the damaged area and Belzona 1341 was used to protect it.
