BELZONA RESTORES TUBE SHEET PROTECTION

ID: 4197

Customer Location: Power station, Cairo, Egypt
Application Date: September 2003

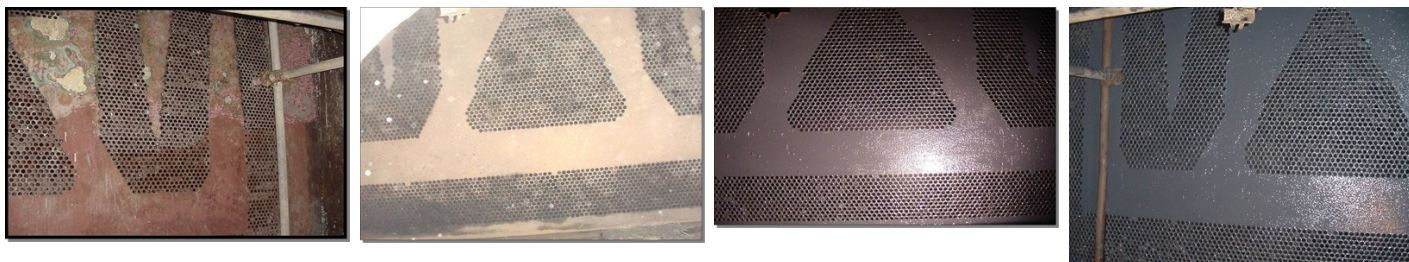
Original coating on tube sheet had failed. Replacement required to prevent future corrosion.

- * Damaged original coating ,
- * After surface preparation ,
- * First coat of Belzona® 1321 applied ,
- * Second coat of Belzona 1321 applied ,

condenser Tube Sheet

The application was carried out in accordance with Belzona System Leaflet HEX-3.

The Belzona repair was carried out quickly, minimizing outage time. Belzona® 1321 has a long track record of providing corrosion protection on such equipment.
