Belzona Rebuilds and Protects Cavitated Fan Vanes

ID: 4202

Customer Location: *Talkha, Egypt*
Application Date: *October 2006*

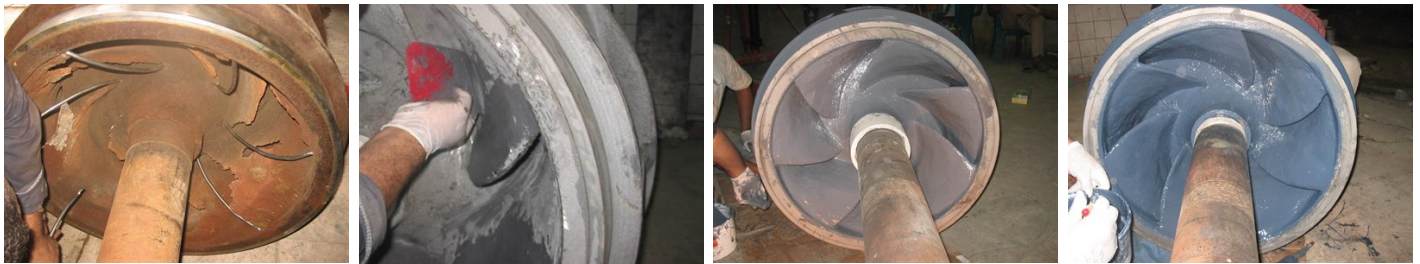
Photograph Descriptions

The fan blades were suffering from the effects of cavitation damage.

- * 1. Damaged Fan Blades ,
- * 2. Belzona 1311 application ,
- * 3. First coat application of Belzona 1321 ,
- * 4. Second coat application of Belzona 1321 ,

The application was carried out in accordance with FBC-1 and FBC-2.

Belzona is able to rebuild and protect the fan vanes with a quick and easy solution. In areas where the vanes are completely eroded metal plates can be positioned into the system.
