# BELZONA PROTECTS PUMP PLINTH

ID: 422

**Application:** TCC-Tanks and Chemical Containment Areas

Pump Plinth

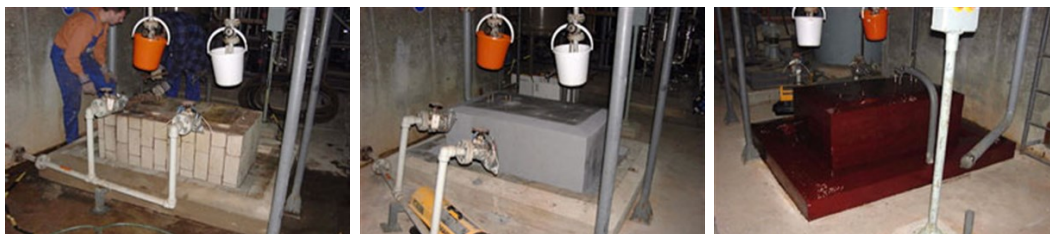
98% Sulphuric acid leaking from the pump had damaged the grout between the acid resistant tiles and attacked the concrete beneath.

- \* The damaged pump plinth ,
- \* Rebuilt with Belzona® 4111 ,
- \* And coated with Belzona® 4341 ,

After removing the tiles and damaged concrete the plinth was rebuilt to the original size with Belzona® 4111. Two coats of Belzona® 4341 were then applied to offer long term, hot acid protection of the plinth.

The Belzona solution provides a seamless barrier to the acids and has no weak spots. Belzona® 4341 can resist up to 75% H<sub>2</sub>SO<sub>4</sub> at 90°C.
