# BELZONA SOLVES LONG TERM LEAK PROBLEMS AT ELECTRICITY SUBSTATION

ID: 4222

**Customer Location:** Electricity Substation, UK  
**Application Date:** September 2012

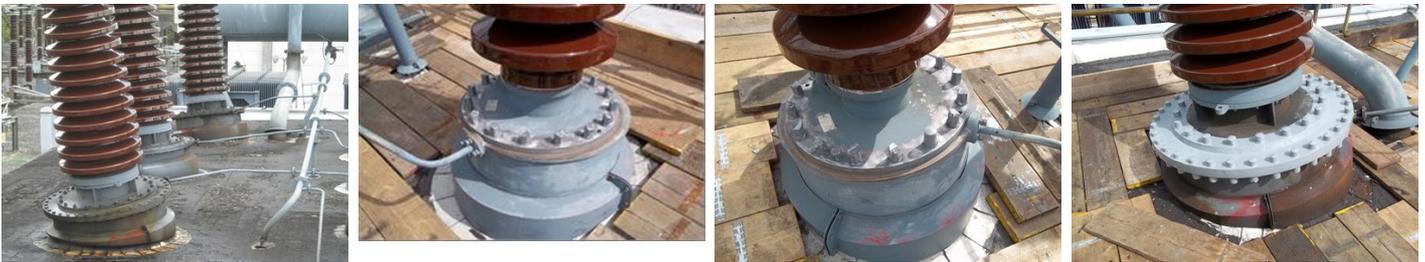
For several years, the transformer had been suffering from extremely high discharges of transformer oil. Following full survey, oil discharges were evident at many of the flange and bolt joints on equipment located in both the interior and exterior of the noise enclosure. A root cause and contributory to the oil leaks were the high voltage and low voltage bushings located to the noise enclosure rooftop.

- \* Three HV bushings during survey ,
- \* LV bushing following substrate preparation and masking bolts ,
- \* LV bushing following the removal of one disposable former ,
- \* HV bushing completed including the encapsulation of bolt heads and coating with Belzona® 5831 for long term protection ,

Application was carried out in accordance with modified versions of Belzona Know-How System Leaflets VPF-8 & 11. After preparing the surfaces active leaks were sealed with Belzona® 1291 or Belzona® 1221. The flange joints were then sealed by applying Belzona® 1161 incorporating Belzona® 9341 (Reinforcement Tape). The bolt and nut heads together with the male studs were fully encapsulated using disposable formers containing Belzona® 1161. Once cured, the formers were removed and all prescribed repair areas were coated with Belzona® 5831.

Six bushings were successfully sealed and in recharging the transformer with oil to the correct level, the bushings did not show any visual evidence of leaking.
