# BELZONA TRANSFORMER LEAK REPAIRS ON TERTIARY BOX

ID: 4223

**Customer Location:** Electricity Substation, UK  
**Application Date:** September 2012

Exterior/Rooftop of Super Grid Transformer Tertiary Box

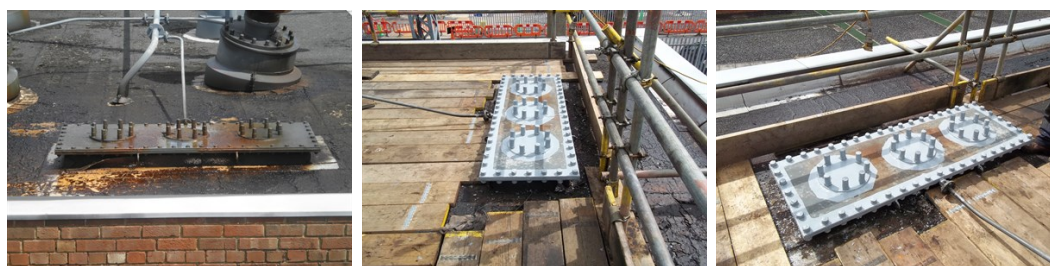
The transformer had been suffering from extremely high losses of transformer oil. Following a site survey, oil discharges were evident at many of the flange and bolt joints to equipment located to both the interior and exterior of the noise enclosure. The root cause of the oil leaks was found to be the tertiary box located in the noise enclosure on the rooftop.

- \* Tertiary Box during survey ,
- \* Completed application ,
- \* Completed application ,

The application was carried out in accordance with modified versions of Belzona Know-How System Leaflets VPF-8 & 11. The tertiary box substrate was prepared before Belzona® 1221 was used to stem any active oil leaks. The flange joint was sealed using Belzona® 1161 incorporating Belzona® 9341 (Reinforcing Tape). Bolt and nut heads, together with male studs were protected by either bridging tape or tight fit former, then fully encapsulated using a disposable former containing Belzona® 1161. Following the curing process, the formers were removed and all of the repair areas were coated with Belzona® 5831.

The leak sealing project was successful. In recharging the transformer with oil to the correct level, neither the flange or bolt heads showed any visual evidence of further leakage. The clients request that the studs be protected prior to encapsulation of the bolt heads was also met.
