# BELZONA® 3211 (LAGSEAL) IN TOUGH ENVIRONMENT - 2ND TIME AROUND

ID: 423

Industry: Power  
Application: TCC-Tanks and Chemical Containment Areas

Customer Location: Power plant in Texas, USA  
Application Date: 2004

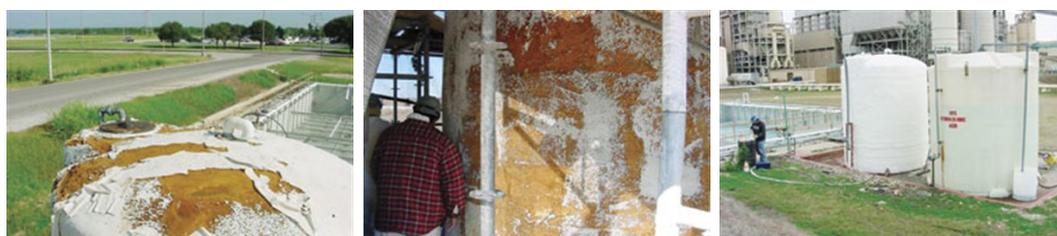
## Photograph Descriptions

- \* View from acid tank ,
- \* Surface preparation ,
- \* Belzona® 3211 applied ,

Coating on insulated caustic storage tank

Belzona® 3211 held up well (eight years) in this tough environment. Fumes from neighboring acid tank condensed on a tank, causing rapid deterioration of the previous coatings.

Once the old coating was removed, the application proceeded in accordance with Belzona® Know-How System Leaflet TCC-4.
