BELZONA RECHARGES SHUNT REACTOR

ID: 4231

Customer Location: Electricity Substation, UK
Application Date: May 2012

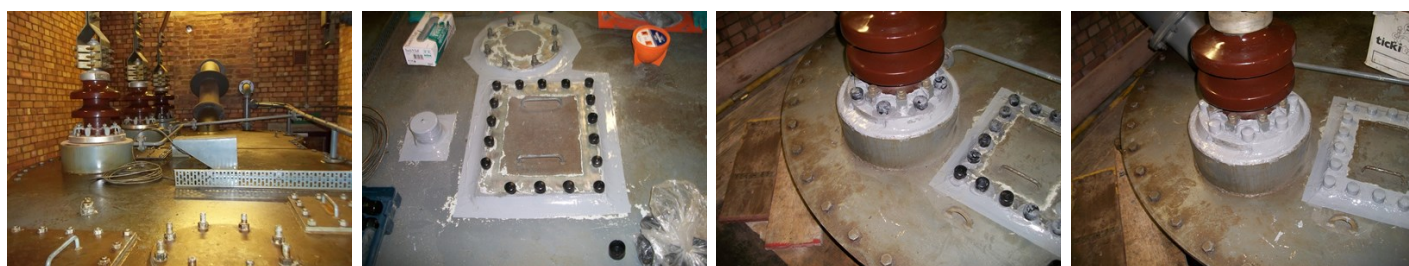
Photograph Descriptions

During operation, the shunt reactor temperature can fluctuate significantly together with movement caused by vibration. The Shunt reactor had been discharging transformer oil for many years due to the difficulties in securing maintenance outages. Following a site survey, oil discharges were evident from the bushings and some inspection Hatches.

- * Shunt reactor prior to application ,
- * Flange joints sealed using Belzona® 1161 ,
- * Encapsulation of bolt and nut heads ,
- * Repair areas coated with Belzona® 5831 ,

Application was carried out in accordance with Belzona Know-How System Leaflet VPF-11. All if the bolt heads were tightened prior to the repair. After preparing the substrate, Belzona® 1291 and Belzona® 1221 were used to stem any active oil leaks. Flange joints were sealed by applying Belzona® 1161 incorporating Belzona® 9341 (Reinforcement Tape). The bolt and nut heads, together with the male studs were fully encapsulated using a disposable former containing Belzona® 1161. Once cured, the formers were removed and the prescribed repair areas were coated with Belzona® 5831.

The leak sealing project was successful in recharging the transformer with oil to the correct level inspection hatches. The bolt heads and bushing flanges showed no further visual signs of leaking. This resulted in significant cost savings and future ease of safe access for the client. The clients request that the studs be protected prior to full encapsulation of the bolt heads to allow access for any future dismantling process was also met.
