# BELZONA IN-SITU REPAIRS TO PORCELAIN INSULATORS

Customer Location: National Grid, UK  
Application Date: October 2012

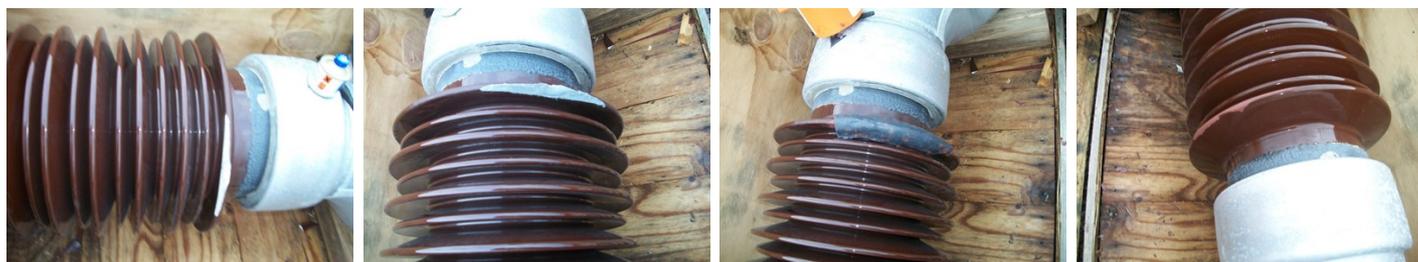
A brand new porcelain shed had been damaged whilst in transit to the Substation which required an immediate in-situ repair.

- \* Damaged porcelain shed in transport crate ,
- \* Shed edge wet out with Belzona® 1221 ,
- \* Belzona Elastomer former containing Belzona® 8112 ,
- \* Completed repair ,

The porcelain insulator rebuild repair was completed in accordance with the Belzona Know-How System Leaflet VPF16.
