BELZONA ELASTOMERS SEAL SF6 GAS LEAK

ID: 4234

Customer Location: Electricity Substation, UK
Application Date: October 2012

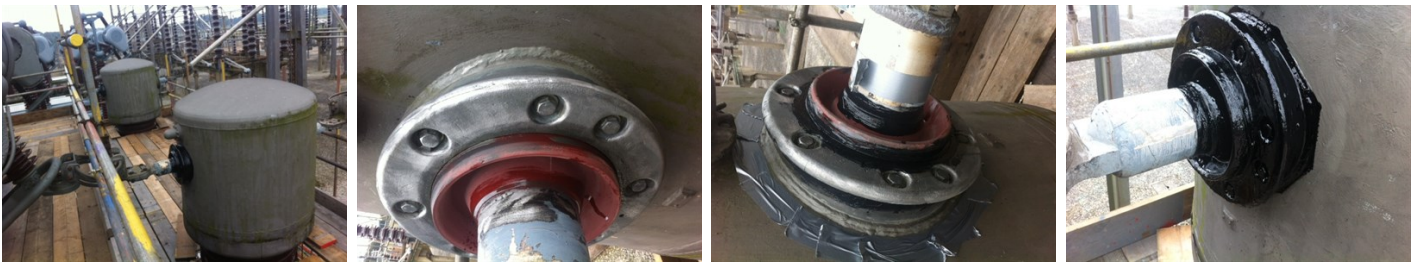
Photograph Descriptions

- * Visual view of equipment – horizontal bus bar ,
- * Substrate preparation completed ,
- * Conditioned and first Elastomer coat/joint sealing ,
- * Completed application with full encapsulation ,

Six capacitor current transformers leaking SF6 gas to Low Voltage side between bus bar and flange. The operating pressure was 45psi.

The application was carried out in accordance with modified versions of Belzona Know-How System Leaflets VPF-5 & VPF-11. After preparing the substrate and conditioning with Belzona® 2911, a fillet was created using Belzona® 2311 to the circumference of the bus bar, flange and rubber gasket joint. After allowing to cure, a gas test was undertaken to establish that the initial leak sealing system was successful. A coat of Belzona® 2111 was then applied to all of the areas of substrate incorporating Belzona® 9341 (Reinforcing Tape). A second coat was then applied to an approximate thickness of 5mm encapsulating the bus bar, all flange surfaces and the branch joint behind the flange.

Upon completion of each of the six applications, gas testing proved zero emission and in turn, the competency of the repairs with a six month review scheduled.
