BELZONE EFFECTS EMERGENCY REPAIRS TO LEAKING SWIMMING POOL

Customer Location: *Public swimming pool, British Columbia, Canada*

Application: *FPA-Floor Problem Areas*

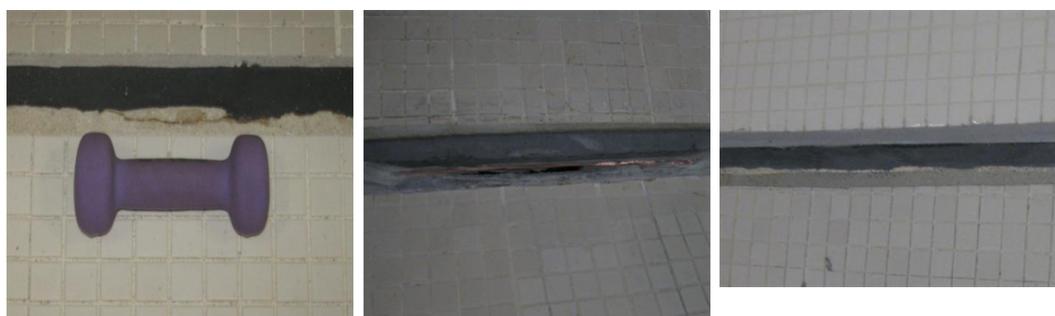
Photograph Descriptions

Vibration from the use of a "jackhammer" by a contractor in the pool basin to expose leaking pipes had caused cracks to develop in the concrete grout forming the edges of this pool's unique expansion joint system. Dye testing located 12 separate leaks.

- * The grout used to form the expansion joint sides, and the crack in it, are visible above the hand weight used to mark leak locations during dye testing ,
- * The void beneath the crack is exposed ,
- * The joint repaired. Twelve separate leaks were isolated and sealed ,

Application was carried out in accordance with Belzona Know-How System Leaflets FPA-5 & FPA-6. Cracked grout was removed and joint edges rebuilt with Belzona® 4111, followed by repair with Belzona MP Elastomer of the expansion joints in affected areas.

The emergency Belzona repairs were completed over a period of two days and the pool was re-opened to the public one week after the Belzona repairs had been completed. Leakage was found to be even lower than before the initial problem had arisen.
