# BELZONA REPLACES HOT TUB EXPANSION JOINTS

ID: 4250

Customer Location: Municipal swimming pool, Coquitlam, British Columbia

Application: FPA-Floor Problem Areas

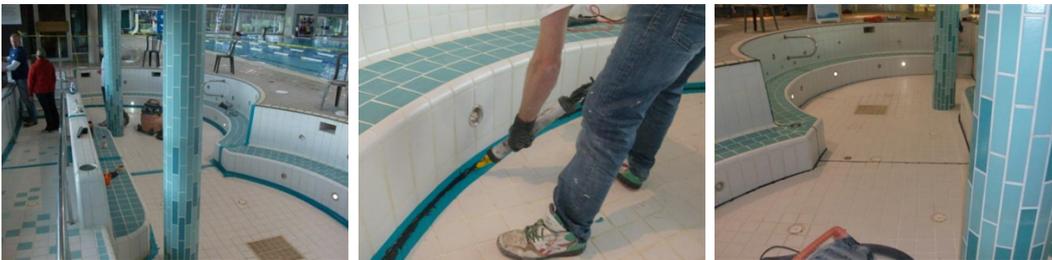
The joint sealing material used during original construction was failing. It could not withstand the elevated operating temperature of the treated water. The material softened and damaged patrons swimming gear.

- \* Preparation underway ,
- \* All horizontal joints are filled with Belzona® 2221 and vertical joints with Belzona® 2211 ,
- \* The masking tape is removed after allowing the product to set up for about 30 minutes ,

Application was carried out in accordance with Belzona Know-How System Leaflet FPA-6. The old original grouting material was cut out and the joints allowed to dry out overnight before the surfaces were ground, vacuumed and then masked off to ensure a neat and tidy joint after injecting Belzona Elastomer into joints.
