BELZONA REPLACES HOT TUB EXPANSION JOINTS

ID: 4250

Customer Location: Municipal swimming pool, Coquitlam,
British Columbia

Application: FPA-Floor Problem Areas

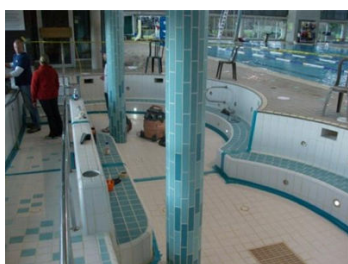
- * Preparation underway ,
- * All horizontal joints are filled with Belzona® 2221 and vertical joints with Belzona® 2211 ,
- * The masking tape is removed after allowing the product to set up for about 30 minutes ,

Application was carried out in accordance with Belzona Know-How System Leaflet FPA-6. The old original grouting material was cut out and the joints allowed to dry out overnight before the surfaces were ground, vacuumed and then masked off to ensure a neat and tidy joint after injecting Belzona Elastomer into joints.
