BELZONA REFURBISHES HEAT EXCHANGER ON CRUISE LINER

ID: 4263

Customer Location: Luxury cruise liner, UK
Application Date: September 2012

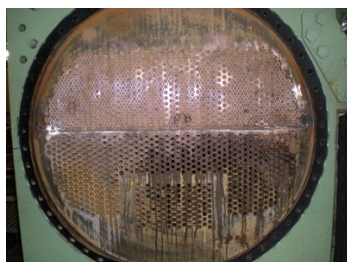
The heat exchanger tube sheet was found to be corroded, with isolated pitting in the division bar seal face.

- * The luxury cruise liner ,
- * Damaged tube face ,
- * Application of Belzona® 1321 ,
- * Completed application ,

The application was carried out in accordance with Belzona Know-How System Leaflets HEX-1 and HEX-3. corrosion pitting was rebuilt with Belzona® 1121 before applying Belzona® 1321 for overall corrosion protection.
