BELZONA REFURBISHMENT OF COOLING WATER PUMP DIFFUSER

Customer Location: *Power station in Egypt*
Application Date: *April 2002*

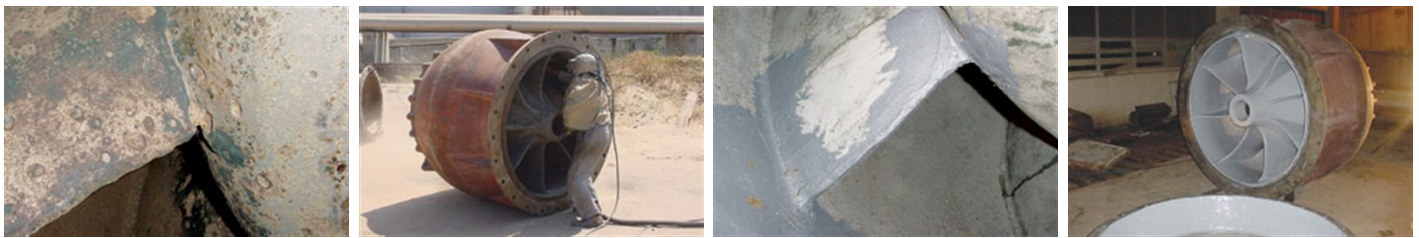
Severe erosion-corrosion.

- * Severity of erosion clearly evident ,
- * Surface preparation by grit blasting ,
- * Erosion rebuilt using Belzona® 1311 ,
- * Coating with Belzona® 1341 underway ,

Diffuser and bell-mouth from main cooling water lift pump.

Application was carried out in accordance with Belzona Know-How System Leaflets CEP-1, CEP-3 and CEP-5.

Importing of new diffuser and bell-mouth would take six months to deliver at cost of \$100,000. Belzona application cost only \$2,800 and the pump was ready to go back to service in 48 hours.
