# BELZONA REPAIRS PLATFORM'S SUMP PIPE

Customer Location: Oil and Gas Platform, Rio Grande do Norte, Brazil

Application: VPF-Valves, Pipes and Fittings

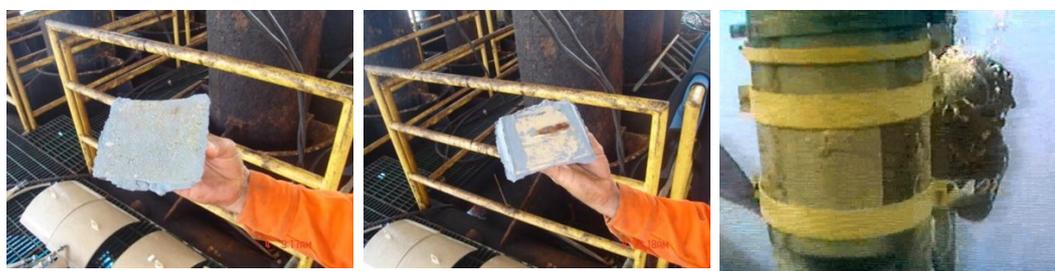
The sump pipe was cracked along its structure due to impact. It was required to seal the affected area using surface tolerant products that could also be used under water.

- \* Adhesion test being carried out with plates coated with Belzona 5811 prior to application. ,
- \* Testing Belzona 1161 on edges of plate under immersed conditions. ,
- \* Application being carried out by divers under water. ,

Surface was cleaned in accordance with ISO 8501-1 St2/3 using a pneumatic sander. Fouling was chiseled away from the metallic structure. Prior to commencement of the application several plates were coated with Belzona 5811/Belzona 5831 to prevent and protect these pieces from further corrosion. Theoretical and practical training was imparted to the divers responsible for applying the products under water. Belzona 1111 was applied onto the panels before submersion. The plates were installed from top to bottom. "U" clamps were used to exert pressure onto the plates and to remove excess material. Belzona 1161 was then used to fill any gaps and to seal the ends of the plates. Upon completion, inspection was carried out and a small leak was detected. The leak was repaired with the Belzona 1161/Belzona 5831 system.
