BELZONA REPAIRS CEMENT BALL MILL

ID: 428

Industry: *Cement*
Application: *SHM-Solids Handling Machinery*

Customer Location: *Cement works in Egypt*
Application Date: *May 2001*

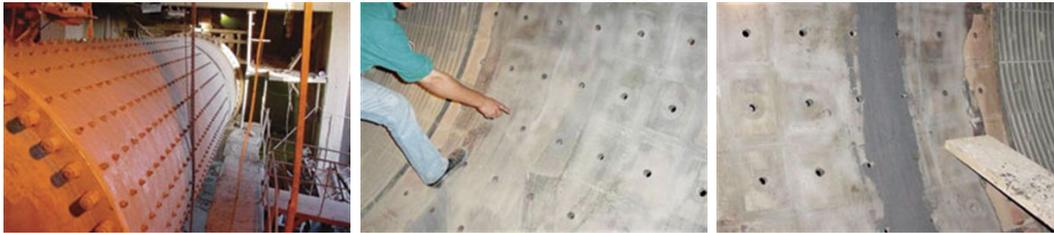
Photograph Descriptions

Wear had occurred on the housing due to breakage of lining tiles which leads to direct impact of milling balls with barrel.

- * General view of the ball mill ,
- * Damage to mill barrel being indicated ,
- * Application of Belzona completed. Wear plates will be bolted in over the repair. ,

Application was carried out in accordance with Belzona Know-How System Leaflet SHM-7.

Belzona® 1111 restored the original dimensions using a simple former in a fraction of both time and cost. A conventional approach to repairing this problem - welding - was not an option due to the large size and difficulty of machining.
