Reparaciones de suelo con Belzona en fábrica de sidra

ID: 4292

Ubicación del cliente: *Fábrica de sidra, Reino Unido*
Fecha de aplicación: *2009*

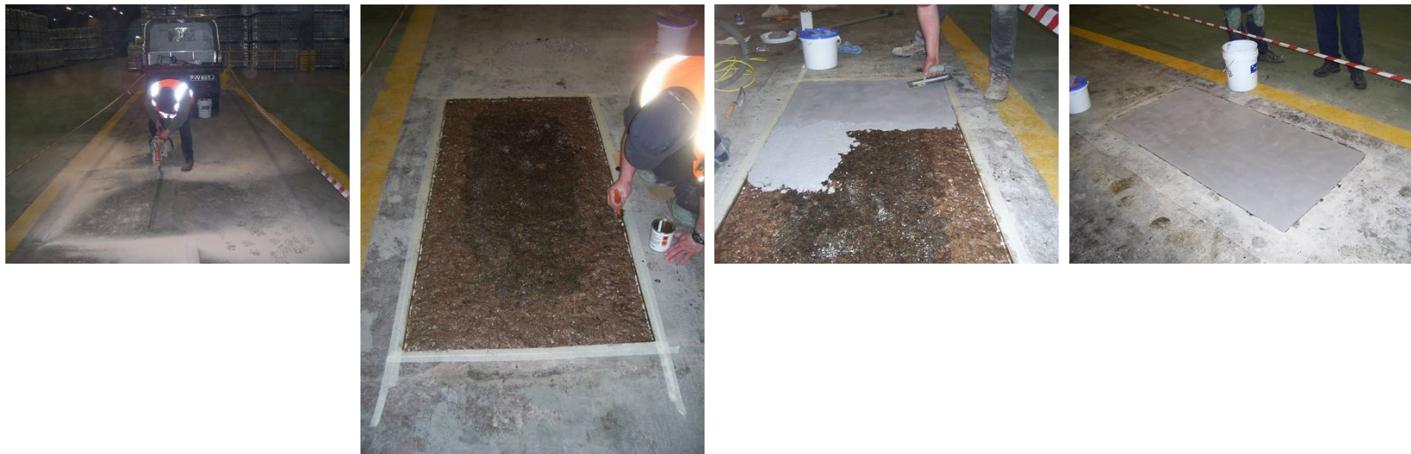
Descripciones de fotografías

Los estabilizadores de los camiones dañaron el área de aparcamiento después de 6-8 meses.

- * Preparaci&on del &rea dañada ,
- * Aplicaci&on del acondicionador ,
- * Aplicaci&on de Belzona® 4131 ,
- * Aplicaci&on finalizada ,

La aplicación se realizó de acuerdo con el folleto Belzona de Sistema Know-How FPA-1.

El suelo reparado y protegido con Belzona® 4131 es capaz de resistir el impacto y la abrasión, por lo que alarga el tiempo en servicio del área de aparcamiento y se reduce por tanto su mantenimiento. El cliente se mostró muy satisfecho con los resultados y este
