LONG LASTING BELZONA STEP REPAIR - EXCELLENT AFTER 20 YEARS

ID: 431

Customer Location: U.S. Air Force Base - Illinois U.S.A.
Application Date: Summer 1984

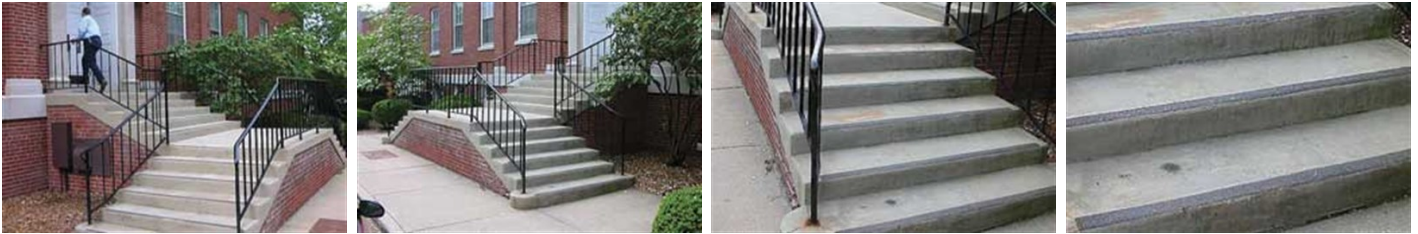
Photograph Descriptions

Cracked steps allowed water to leak and pool under the steps where the main building transformer is located. Of secondary concern was the absence of slip protection on the step noses.

* 1. to 4. Various angles of the steps. ,

All the steps and landings were rebuilt/coated with 1/4" of Belzona® 4111. Strips of Belzona® (Ceramic S-Metal) and coarse aggregate were applied for safety. Repouring of the steps would have been very expensive and most likely would have suffered the same problem after a period of time. After 20 years the steps and the non-skid are still in excellent condition. The photos were taken in April of 2004.
