# BELZONA SEALS OIL LEAKS ON TRANSFORMER BUSHINGS

ID: 4310

**Customer Location:** Gas-Fired Power Plant - Toronto, Canada  
**Application Date:** June 2012

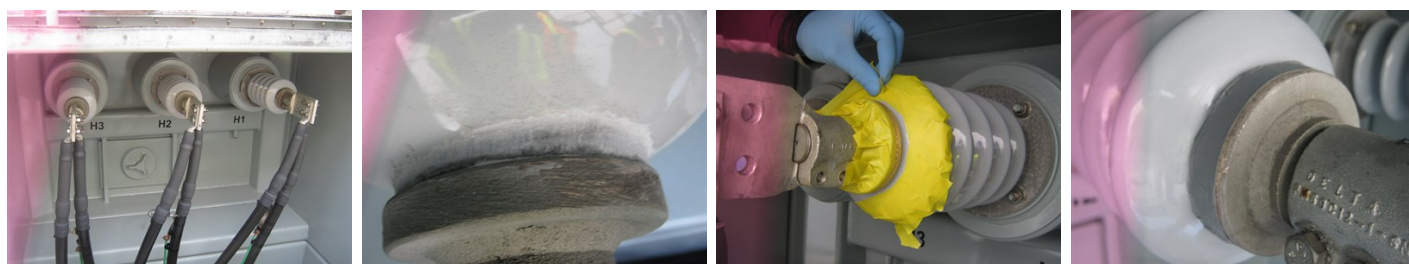
*It was noted that a small oil leak was present at the bushing. No oil should leak from this bushing. The heavy electrical cables were not supported adequately.*

- \* Transformer bushings ,
- \* Ceramic insulator after abrading with Dremel and cleaning ,
- \* Ceramic insulator and bushing masked off ,
- \* Application completed ,

Application was carried out in accordance with Belzona Know-How System Leaflet VPF-11. The ceramic insulator was roughened with a Dremel before applying the Belzona 1161 by brush to seal the oil leaks.
