BELZONA REBUILDS MARINE DIESEL ENGINE BLOCK

Application: ENC-Engines and Casings

Caterpillar diesel engine on passenger ferry.

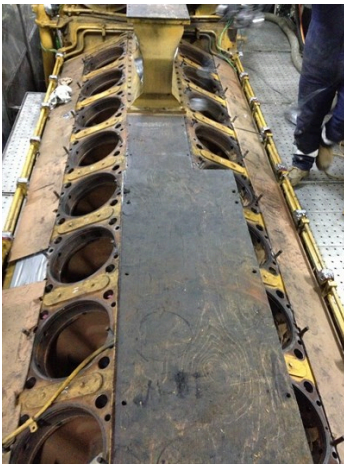
Cylinders from the port outer main engine were suffering from severe cavitation beyond the original Belzona repair. Belzona has been routinely used to repair these areas for over 10 years.

- * 1. General view of the engine Cavitation damage around the existing Belzona® 1311 ,
- * 2. Area ground out to depth of 3mm ,
- * 3. Blasted area in preparation for coating with Belzona® 1391 ,
- * 4. Completed Belzona® 1311 repair ,

Application carried out in accordance with Belzona System Leaflet ENC-6 and engine manufacturers repair procedures. Old repair ground out along with deep pitting. After vacuum blasting area Belzona® 1311 applied to restore profiles. A former was used to create skirt around the cylinder. Area was then flash blasted in preparation for coating with Belzona® 1391.
