BELZONA REBUILDS MARINE DIESEL ENGINE BLOCK

ID: 4344

Application: ENC-Engines and Casings

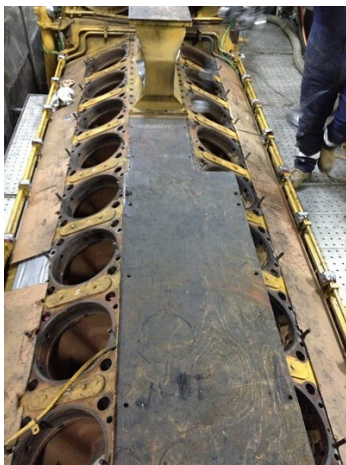
Cylinders from the port outer main engine were suffering from severe cavitation beyond the original Belzona repair. Belzona has been routinely used to repair these areas for over 10 years.

- * 1. General view of the engine Cavitation damage around the existing Belzona® 1311 ,
- * 2. Area ground out to depth of 3mm ,
- * 3. Blasted area in preparation for coating with Belzona® 1391 ,
- * 4. Completed Belzona® 1311 repair ,

Application carried out in accordance with Belzona System Leaflet ENC-6 and engine manufacturers repair procedures. Old repair ground out along with deep pitting. After vacuum blasting area Belzona® 1311 applied to restore profiles. A former was used to create skirt around the cylinder. Area was then flash blasted in preparation for coating with Belzona® 1391.
