BELZONA REBUILDS MARINE DIESEL ENGINE BLOCK

Customer Location: Dockyard, Belfast

Application: ENC-Engines and Casings

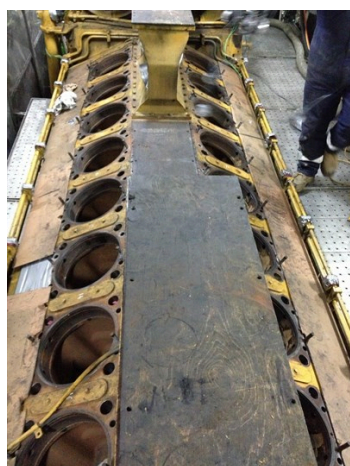
Cylinders from the port outer main engine were suffering from severe cavitation beyond the original Belzona repair. Belzona has been routinely used to repair these areas for over 10 years.

- * 1. General view of the engine Cavitation damage around the existing Belzona® 1311 ,
- * 2. Area ground out to depth of 3mm ,
- * 3. Blasted area in preparation for coating with Belzona® 1391 ,
- * 4. Completed Belzona® 1311 repair ,
