SF6 GAS LEAKS SEALED WITH BELZONA

ID: 4357

Gas insulated electrical switchgear

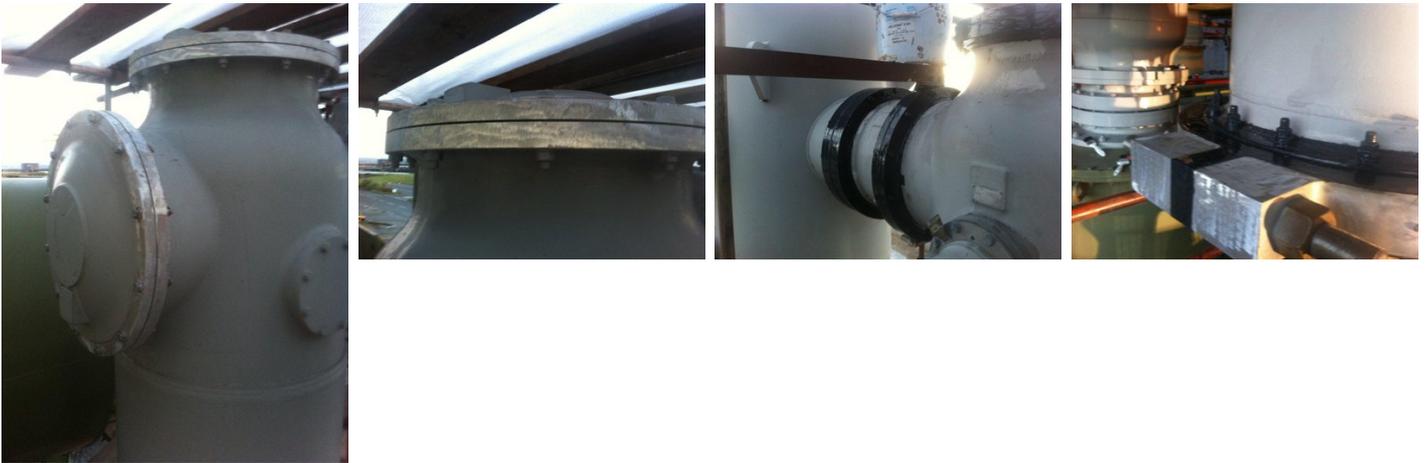
Failure of the original sealant between the bolted flanges had resulted in loss of containment of the insulating SF6 gas, a potent greenhouse gas.

- * Bolted joints prior to application ,
- * Surface Preparation carried out using a disc grinder and solvent cleaning ,
- * Joints sealed with Belzona® 2221 coating ,
- * Bolts were also encapsulated, completely stopping leakage of SF6 gas in all accessible areas ,

Application was carried out using a modified version of Belzona System Leaflet TCC-1. The equipment operator lowered the pressure inside the equipment prior to the application. The area was thoroughly cleaned and roughened before the flange and bolts were completely encapsulated with the Belzona® 2221 focusing on the gap between the bolted faces. Once cured, the equipment was re-pressurized and tested for leaks.

With no other alternatives, the national energy supplier turned to Belzona to seal these leaks. The Belzona Distributor, Beltech, successfully sealed 95% of the leaks on this initial application with the remaining 5% inaccessible due to equipment design. The dramatically reduced gas losses resulted in massive cost savings to the client, reduced environmental impact and has led to further applications in these areas.
