NON-SLIP SAFETY SYSTEM IN HOSPITAL DISH WASHING ROOM

ID: 436

Customer Location: *Regional Hospital - British Columbia, Canada*

Application: *FPA-Floor Problem Areas*

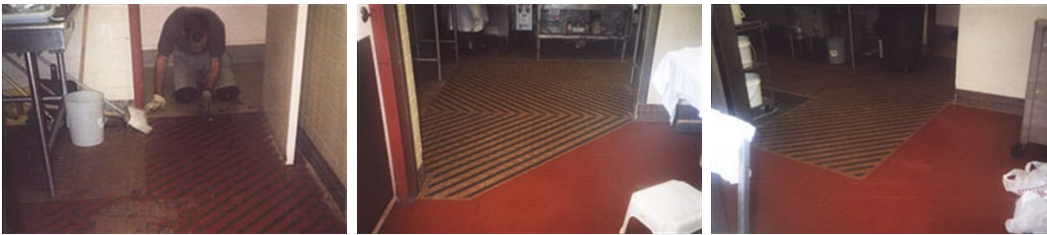
Inferior non-slip safety system

- * Previous failed system being stripped from the floor ,
- * View of application ,
- * View of another section of the application ,

Customer had contracted with another vendor to apply a non-slip safety system to the dish wash room floor. However, soon after completion of the application, it was found that the surface was extremely slippery. Belzona was approached to apply our standard system over this coating. Within a few months the inferior coating started to delaminate. We were contracted to remove all the red coating and apply a Belzona safety grip system directly to the original floor tiles. Photograph shows removal in progress.

Application was carried out in accordance with Belzona Know-How System Leaflet FPA-8.
