# Belzona repair erosion/corrosion damage to Absorber

ID: 4361

Carbon Steel Bubbler Hood

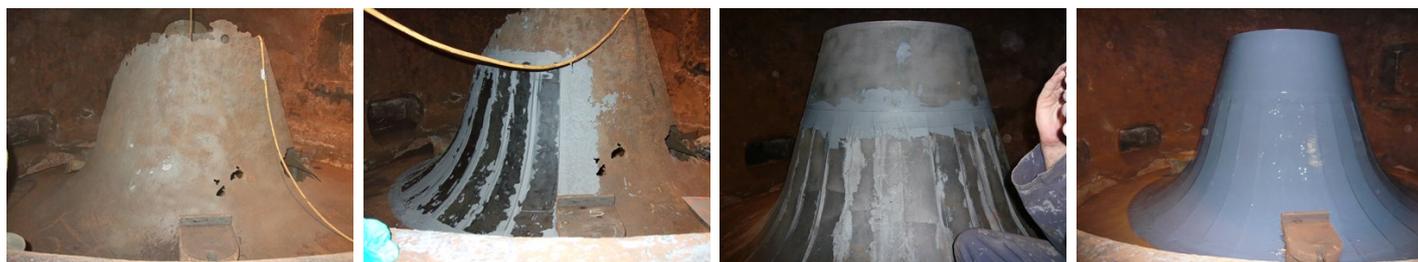
Extensive damage to equipment caused by erosion corrosion issues.

- \* Bubbler Hood post blasting ,
- \* Bonding of plates using Belzona 1121 ,
- \* Bonding of new dome piece ,
- \* Overcoating of application using Belzona 1391 ,

This application was carried out with a modified version of Belzona Know-How System Leaflet TCC-5. After surface preparation was completed by grit blasting Belzona 1121 was used utilising its extended working life to bond the large contoured plates to damaged area then Belzona 1391 was applied to give maximum protection to process conditions.
