# BELZONA PROVEN SOLUTION FOR CONDENSER MAINTENANCE

**Customer Location:** CCGT Power Station, North Wales, UK  
**Application Date:** March 2012

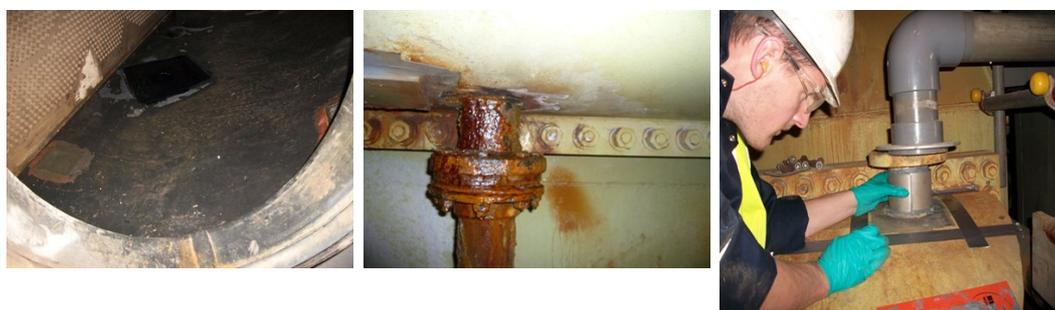
- \* Internal lining repairs ,
- \* One of the corroded drain pipes ,
- \* Split collar being bonded to vent pipe using Belzona® 1161 ,
- \* Completed repair to vent pipe after coating with Belzona® 5831 ,

Condenser water boxes at a Combined Cycle Gas Turbine (CCGT) power station. Annually over the past 5 years Belzona® 2141 has been successfully used to carry out repairs to the internal lining. In 2012 engineers at the power station identified severe corrosion at the external vents and drain pipes which was resulting in leakage.

Application was carried out in accordance with Belzona system Leaflets HEX-3, 4 & 9. At areas of high cavitation, Belzona 2141 was used as a patch repair to the internal lining. Collars (curved plates) were formed and bonded with Belzona® 1161 to the vent and drain pipes. The repair area was then over coated with Belzona® 5831 to reinforce the repair and to protect against further corrosion.
