# BELZONA PROVEN SOLUTION FOR CONDENSER MAINTENANCE

Industry: Power  
Application: HEX-Heat Exchangers  
Substrate: Steel  
Products: \* Belzona® 2141 (ACR-Fluid Elastomer) ,  
\* Belzona® 1161 (Super UW-Metal) ,  
\* Belzona® 5831 (ST-Barrier) ,

Customer Location: CCGT Power Station, North Wales, UK  
Application Date: March 2012

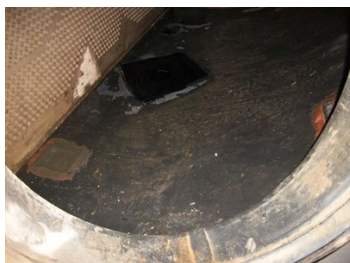
- \* Internal lining repairs ,
- \* One of the corroded drain pipes ,
- \* Split collar being bonded to vent pipe using Belzona® 1161 ,
- \* Completed repair to vent pipe after coating with Belzona® 5831 ,

Application was carried out in accordance with Belzona system Leaflets HEX-3, 4 & 9. At areas of high cavitation, Belzona 2141 was used as a patch repair to the internal lining. Collars (curved plates) were formed and bonded with Belzona® 1161 to the vent and drain pipes. The repair area was then over coated with Belzona® 5831 to reinforce the repair and to protect against further corrosion.

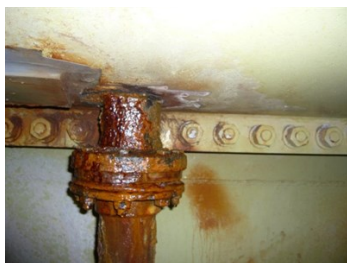
Condenser water boxes at a Combined Cycle Gas Turbine (CCGT) power station. Annually over the past 5 years Belzona® 2141 has been successfully used to carry out repairs to the internal lining. In 2012 engineers at the power station identified severe corrosion at the external vents and drain pipes which was resulting in leakage.
