NON-SLIP SAFETY SYSTEM SUPERIOR TO SAFETY 'STRIPS'

ID: 438

Customer Location: Regional Hospital - British Columbia, Canada.

Application: FPA-Floor Problem Areas

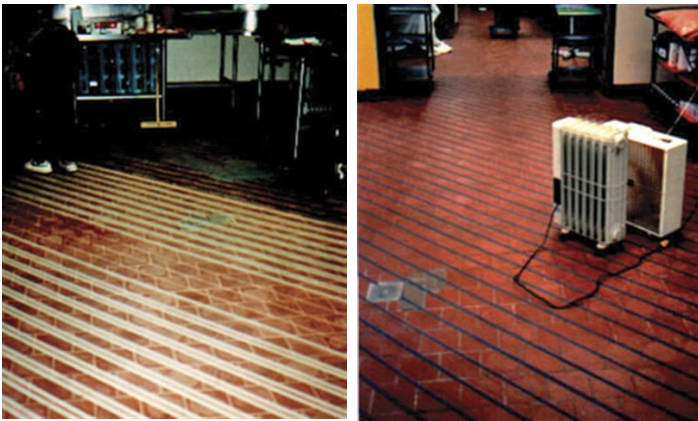
Hospital kitchen and dish washing areas were a constant safety problem because of wet floors. Stick on safety strips were in use but had to be replaced on a regular basis. Also loose strips posed an addition problem of tripping.

- * Preparation underway using a straight edge template and a saw fitted with a double half inch masonry cutting blade and vacuum. This involved a double pass to achieve the desired 1-inch prepared strip. Masking tape was applied to the edges. ,
- * Completed application. ,

Slippery quarry tile floor.

Application was carried out in accordance with Belzona Know-How System Leaflet FPA-8.

The Belzona system, long term, has been cheaper as it eliminated the constant replacement costs incurred by the 'stick on' safety pads. Contrary to original opinion, cleaning did not pose a problem for the housekeeping staff. Safety was also enhanced as loose

or missing strips no longer posed the additional safety problems. This application was extended to other areas.
