# BELZONA PROTECTS OFFSHORE CONDUCTOR CABLE

ID: 4382

Customer Location: Oil Producer, North Sea, Norwegian Sector

Application: SHM-Solids Handling Machinery

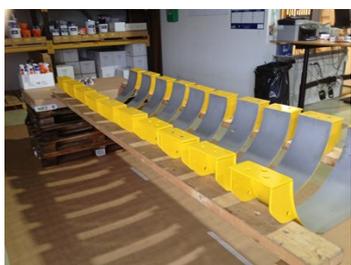
- \* First stack of clamps ready for application ,
- \* Belzona® 2141 applied ,
- \* Splash zone clamps assembled ,
- \* Underwater clamp assembly in place ,

Application was carried out using a modified version of Belzona System Leaflet SHM-9. Internal areas of clamps were lined with 1mm of Belzona® 2141. An approved paint was applied to exteriors.
