BELZONA PROTECTS OFFSHORE CONDUCTOR CABLE

ID: 4382

Customer Location: Oil Producer, North Sea, Norwegian Sector

Application: SHM-Solids Handling Machinery

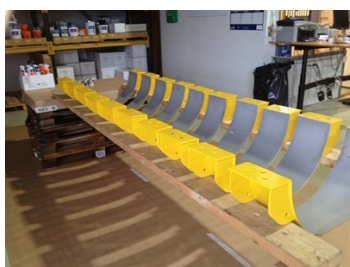
- * First stack of clamps ready for application ,
- * Belzona® 2141 applied ,
- * Splash zone clamps assembled ,
- * Underwater clamp assembly in place ,

Application was carried out using a modified version of Belzona System Leaflet SHM-9. Internal areas of clamps were lined with 1mm of Belzona® 2141. An approved paint was applied to exteriors.
