BELZONA MAINTAINS POWER PLANT MAIN COOLING WATER SYSTEM

ID: 4385

Customer Location: Nuclear Power plant, France
Application Date: July 2012

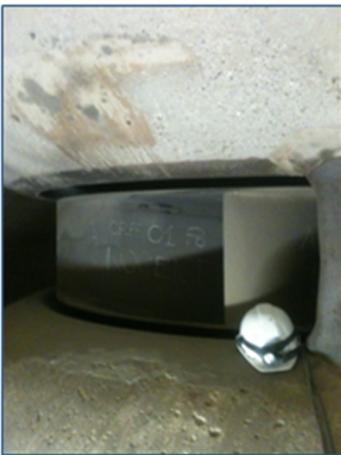
The continuous flow of water through the system had caused the concrete construction to wear both upstream and downstream of the pump, as well as inside the pump volute. This erosive wear had led to micro cracking of the concrete. In addition the rough concrete surface had led to a loss of efficiency as the worn concrete walls created a more turbulent flow.

- * Volute prior to application ,
- * Application of Belzona® 4111 completed ,
- * Application of Belzona® 1341 ,
- * View of the volute following repair ,
