# BELZONA MAINTAINS POWER PLANT MAIN COOLING WATER SYSTEM

ID: 4385

Customer Location: Nuclear Power plant, France  
Application Date: July 2012

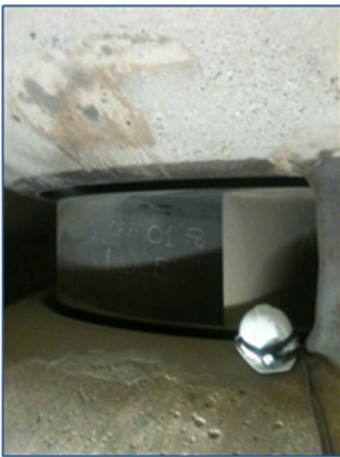
The continuous flow of water through the system had caused the concrete construction to wear both upstream and downstream of the pump, as well as inside the pump volute. This erosive wear had led to micro cracking of the concrete. In addition the rough concrete surface had led to a loss of efficiency as the worn concrete walls created a more turbulent flow.

- \* Volute prior to application ,
- \* Application of Belzona® 4111 completed ,
- \* Application of Belzona® 1341 ,
- \* View of the volute following repair ,
