# DISH WASHING ROOM - SAFER WITH BELZONA SYSTEM

ID: 439

**Application:** FPA-Floor Problem Areas

**Application Date:** November 1, 2001

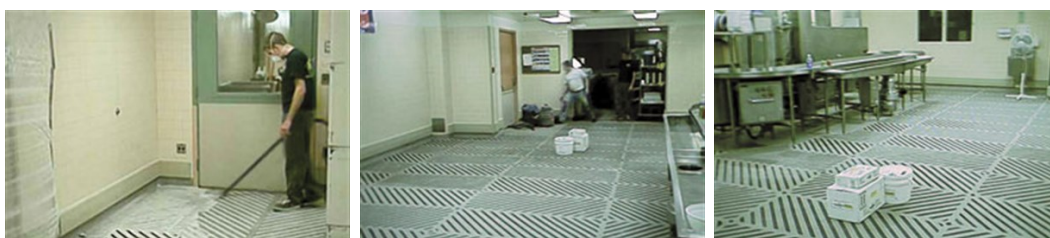
## Photograph Descriptions

- \* Preparation underway using a special silicon carbide grinding tool and template ,
- \* Hospital opted for various different 'chevron' style patterns to help break up the areas ,
- \* Another view of application with a different pattern ,

Safety system required in care centre dishwashing room. Total area completed approximately 700 square feet.

Application was carried out in accordance with Belzona Know-How System Leaflet FPA-8.
