BELZONA LAP JOINT REPAIR AT SAWMILL

Application: *SHM-Solids Handling Machinery*

Customer Location: *Sawmill in Ontario, Canada*

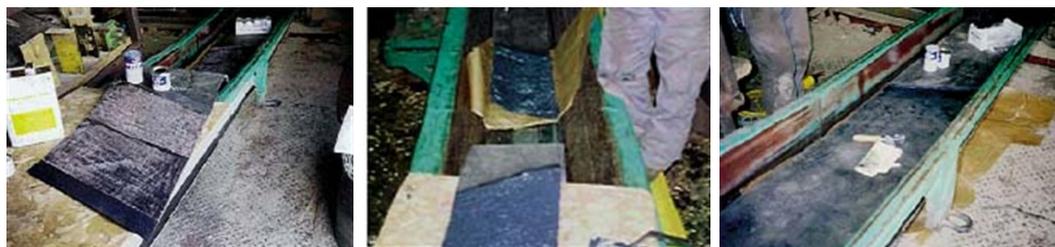
Photograph Descriptions

Fine pieces of veneer and moisture contributed to joint deterioration and failure within a matter of a few weeks.

- * Delaminated lap joint being prepared for the Belzona application ,
- * Both halves of the belt were coated with Belzona® 2111 ,
- * The lap joint bonded together for a long lasting, durable, in-place repair ,

The customer now uses Belzona to bond the joints of the belt which lasts approximately six months, instead of a matter of weeks.
