# BELZONA LAP JOINT REPAIR AT SAWMILL

Application: SHM-Solids Handling Machinery

Customer Location: Sawmill in Ontario, Canada

Application Date: June 1994

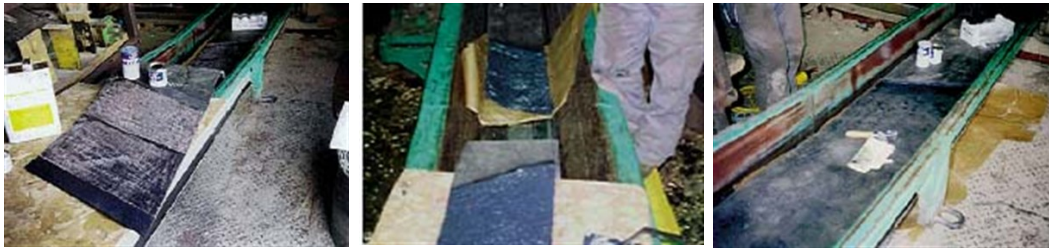
*Fine pieces of veneer and moisture contributed to joint deterioration and failure within a matter of a few weeks.*

- \* Delaminated lap joint being prepared for the Belzona application ,
- \* Both halves of the belt were coated with Belzona® 2111 ,
- \* The lap joint bonded together for a long lasting, durable, in-place repair ,

The customer now uses Belzona to bond the joints of the belt which lasts approximately six months, instead of a matter of weeks.
