WET FLOORS MADE SAFE WITH BELZONA

ID: 440

Customer Location: *Hospital - Victoria, British Columbia, Canada*

Application: *FPA-Floor Problem Areas*

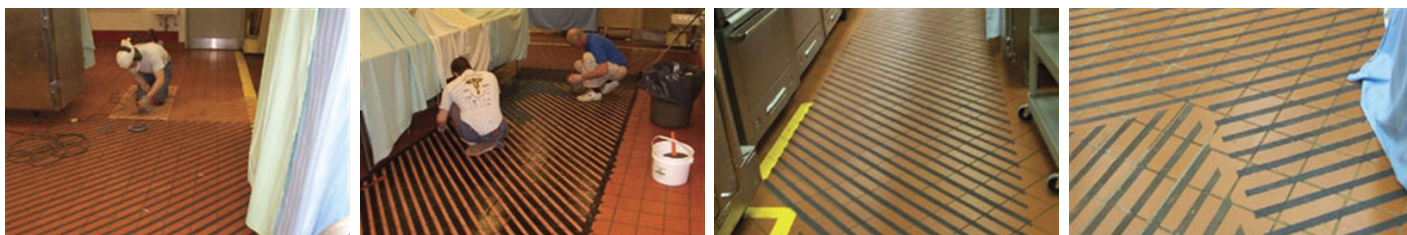
Photograph Descriptions

- * Preparation underway using special silicon carbide grinding tool and template ,
- * Masking completed and application of grip system in progress ,
- * View of completed section of food prep area ,
- * View of completed wash area ,

Non-slip safety system required on quarry tiled dish washroom and food preparation area floors which were constantly wet.

Application was carried out in accordance with Belzona Know-How System Leaflet FPA-8.

Because the floors were constantly wet, there was always a threat that a serious accident could take place at any moment. A non-slip coating had been applied to other areas of the kitchen floor but this had proved to be ineffective over the long term. The coating had also started to loose adhesion in various places increasing the possibility of bacteria growth between it and the tiles beneath.
