BELZONA® 1521 PROTECTS HYDROCYCLONE

ID: 441

Customer Location: North Sea Oil Producer
Application Date: April 2004

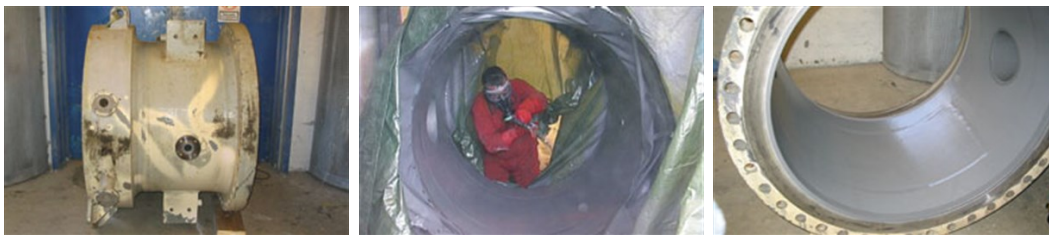
Failure of the existing glass flake lining had led to corrosion of the hydrocyclone body, which operates at elevated temperature.

- * Hydrocyclone body ,
- * Application of Belzona® 1521 in progress ,
- * Completed application ,

Belzona® 1521 was applied to the hydro cyclone vessel body using heated airless spray following grit-blasting. Nozzles were coated internally by brush.
