# LEAKY ROOF IS NO PROBLEM FOR BELZONA

ID: 443

**Customer Location:** Factory roof - Texas U.S.A.  
**Application Date:** 2001 thru 2004

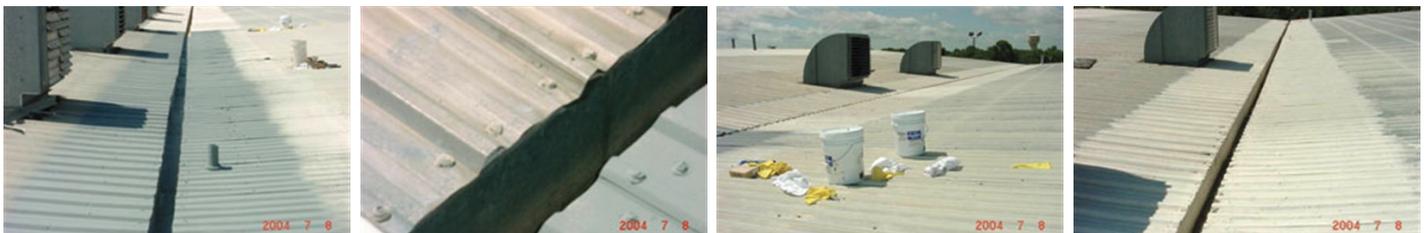
Galvanized roof had numerous leaks around gutters. Previous attempts to stop leaks with conventional roofing materials failed.

- \* Conditioned and coated ,
- \* Roof gutters ,
- \* View of roof area ,
- \* Another view of the gutters ,

Areas were cleaned, conditioned and two coats of Belzona® 3111 were brushed on. The total area protected with Belzona® 3111 was 8,000 sq. ft.
