BELZONA REPAIR AND PROTECTION OF REFRIGERATION UNIT

Application: HEX-Heat Exchangers

Customer Location: Five star hotel in Egypt

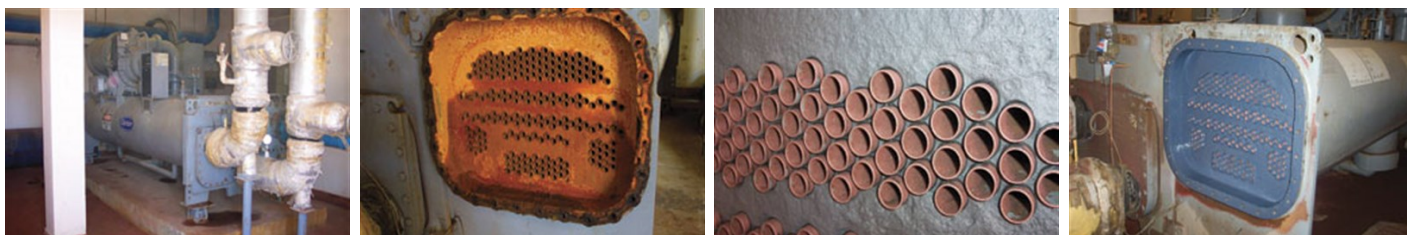
Erosion-corrosion on all water side components. Particularly deep erosion on tube sheet around the tubes.

- * General view of the refrigeration unit ,
- * The corroded tube sheet ,
- * The degree of erosion clearly evident after surface preparation ,
- * Completed application ,

Eroded metal rebuilt with Belzona® 1311 before all surfaces were protected with two coats of Belzona® 1321. Long term repair and protection given insitu, with minimum disruption to plant operation.
