BELZONA ROUTINE CYLINDER SALVAGE OF ENGINE BLOCK

Cavitation damage in water jacket

Diesel engine block from large river cruise ship

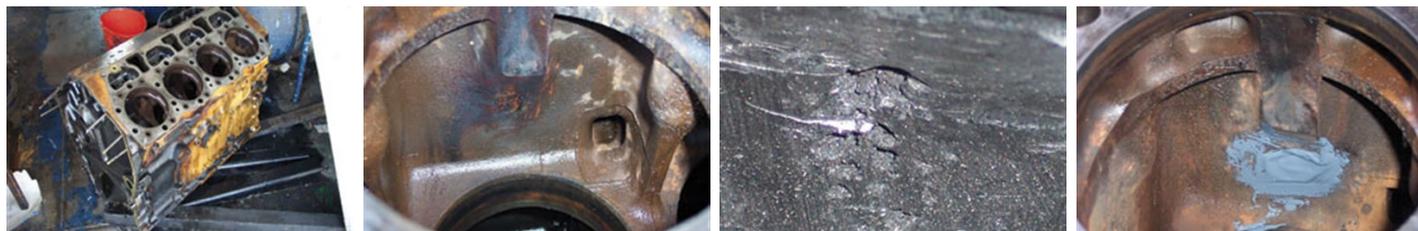
Photograph Descriptions

- * The engine block ,
- * Location of damage ,
- * Close up of the cavitation ,
- * Completed application ,

Application was carried out in accordance with Belzona Know-How System Leaflet ENC-6.

This is a routine repair on engine blocks as cavitation is a common problem in this area of the engine. Belzona provides a quick effective repair without heat and provides good cavitation resistance in the hot coolant.
